ISLAND
INSPECTIONS

1600 Anywhere Street, Orange Beach, AL 36561
Inspection prepared for: Mr. Home Buyer
Date of Inspection: 12/17/2015

Report Summary

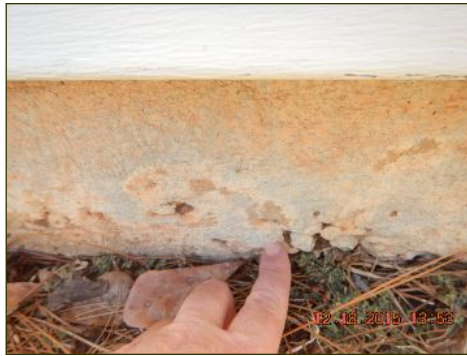
2.1. Common cracking was noted on the foundation walls

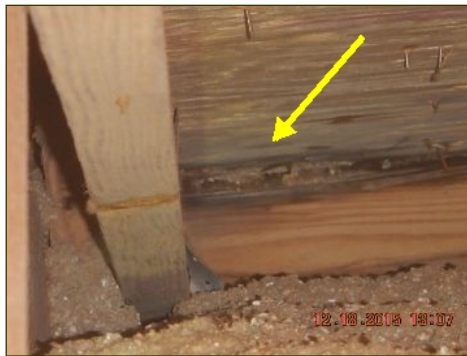
7.1. • Repair: Moisture intrusion was apparent where the the flat roof/chimney servicing the porch meets the home. Rot/deterioration was apparent on the roof sheathing. The chimney is within close proximity of the damaged sheathing. While it is suspected the chimney is the source of the leak, it could not be confirmed at the time of the inspection. Moisture intrusion was also observed on the North side of the home at the bottom of the roof decking within close proximity to the eave. This is believed to be from unsealed shingles. These areas should be further evaluated and repaired by a qualified roofing contractor.

Rot/Deterioration noted by flat roof-chimney

Page 6 Item: 7	Ceiling & Roof	7.1. • Repair: Moisture intrusion was apparent where the the flat roof/chimney servicing the porch meets the home. Rot/deterioration was apparent on the roof sheathing. The chimney is within close proximity of the damaged sheathing. While it is suspected the chimney is the source of the leak, it could not be confirmed at the time of the inspection. Moisture intrusion was also observed on the North side of the home at the bottom of the roof decking within close proximity to the eave. This is believed to be from unsealed shingles. These areas should be further evaluated and repaired by a qualified roofing contractor.
----------------	----------------	--

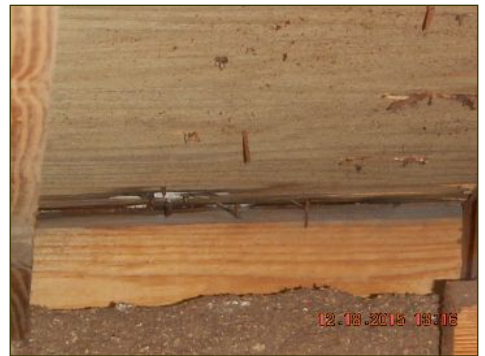
Rot/deterioration noted at north side of home

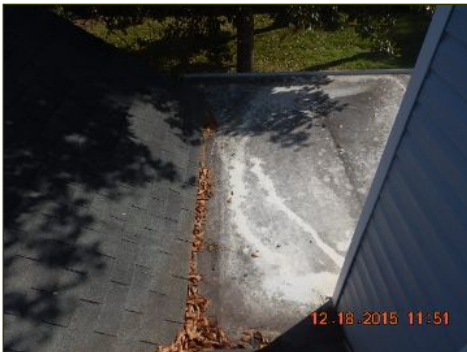
4.8. • Repair: Debris should be removed from the roof.

Recommend removing debris from roof

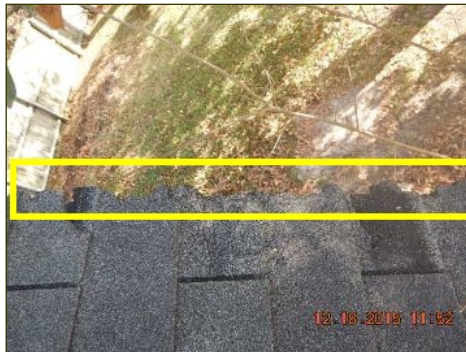
4.6. • Repair: The shingles were observed damaged in various locations. Locations: East, West & South sides

Damage observed on shingles at various locations

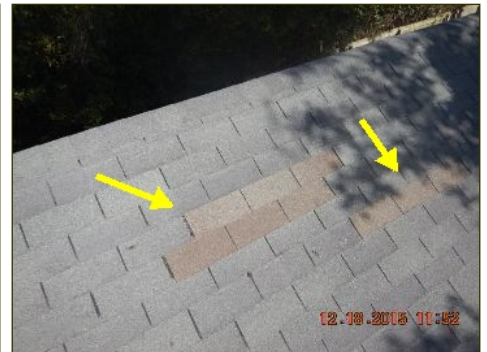
4.3. • Monitor: Prior repairs were observed on the roof. This was apparent by the variation of different colored shingles.

Different colored shingles suggest Prior repairs

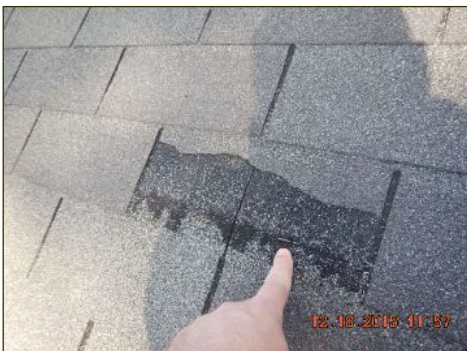
Damaged shingle at west side of home

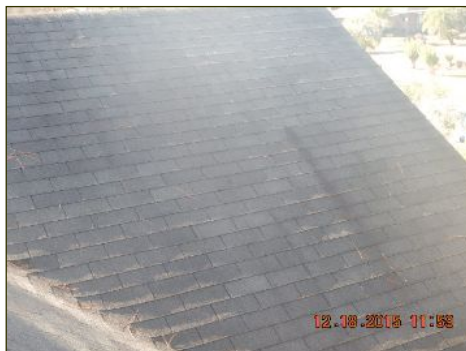
4.2. • Monitor: Minor algae staining was observed on the roof in various locations.

Staining noted on roof covering

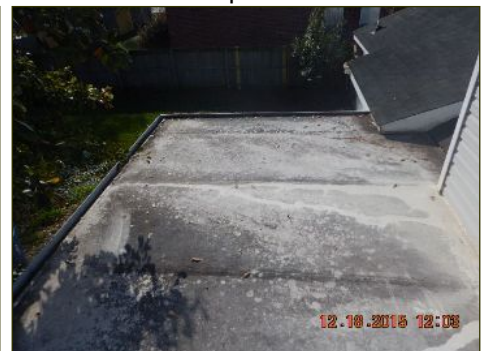
4.5. • Monitor: Prior repairs were observed on the flat roof servicing the porch. The roof is designed in a manner that does not promote proper drainage. This should be further evaluated by a qualified roofing contractor.

Flat roof vulnerable

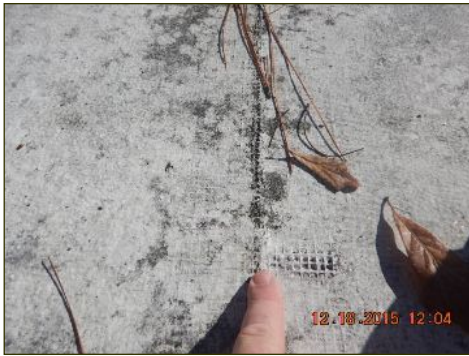
Prior repairs observed on porch roof

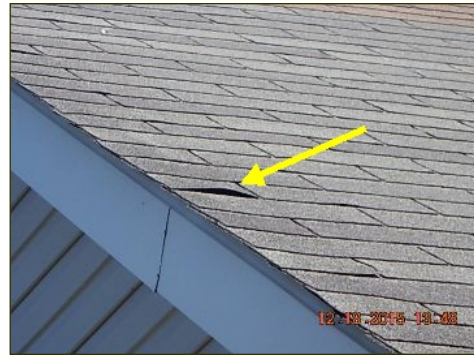
4.7. • Repair: Roofing shingles were observed unsealed in various locations. These should be sealed to avoid moisture intrusion.

Shingles should be sealed

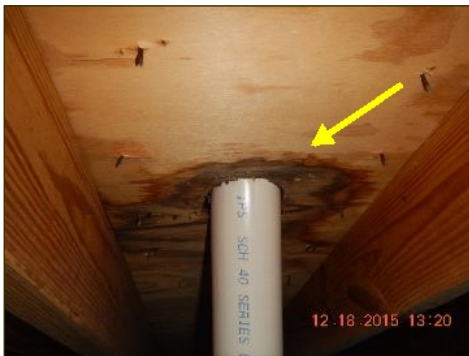
5.1. • Monitor: Moisture staining was noted on the roof sheathing below the plumbing vent flashings in various locations. Although the areas were dry at the time of the inspection, signs of leaking were apparent on the insulation below.

Staining below plumbing vent flashings

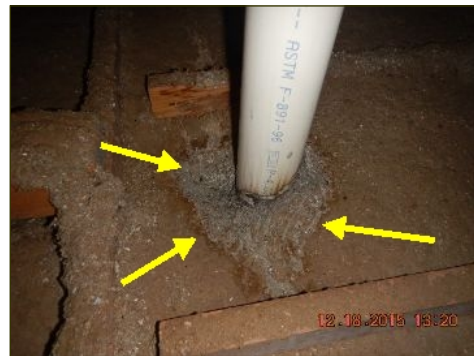
Insulation stained below flashing

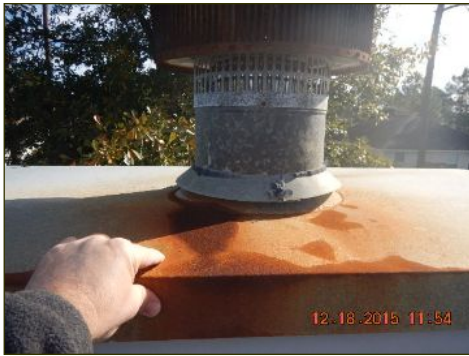
6.1. FYI: The chimney chase cap was rusted with no visible damage. The inspector recommends having the chase cap cleaned, primed, painted and sealed to prevent damage to the cap.

Rust noted on chimney

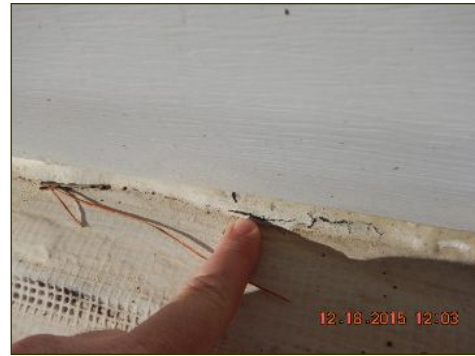
Sealant needed at chimney

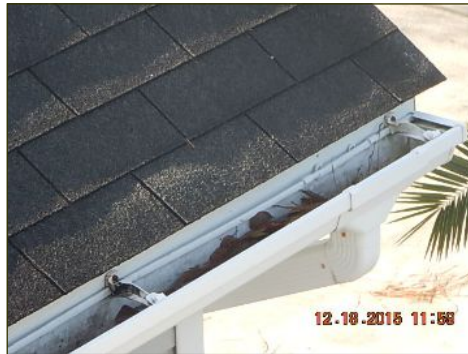
7.1. • **Repair:** Debris was observed in the gutters at the time of the inspection. Recommend cleaning the gutters and monitoring monthly.

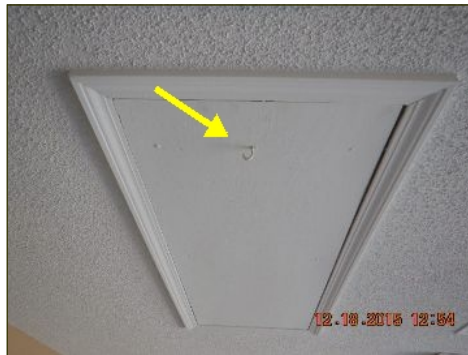
9.1. • Improve: The attic entrance was missing the pull down rope. This is used for accessing the attic.

Access missing pull down string

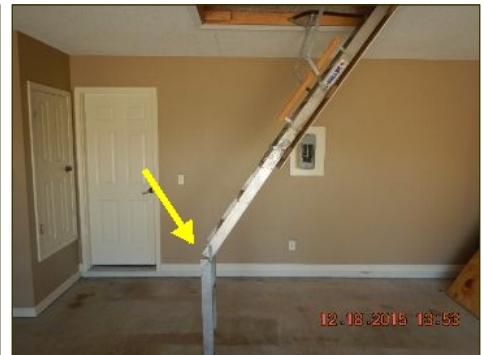
9.2. • Safety Issue: The stairs servicing the attic entrance were operating in a manner inconsistent with its intended purpose. This represents a trip hazard, and should be repaired for improved safety.

Attic stairs not folding properly

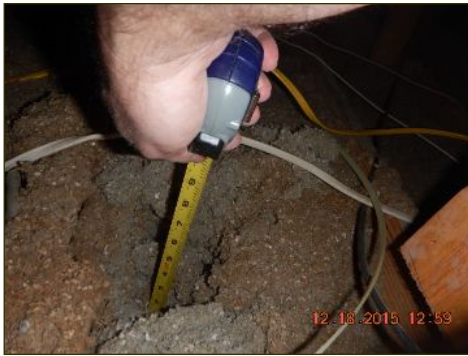
11.3. • FYI: Upgrading insulation levels may be desirable

Upgrading insulation may be desirable

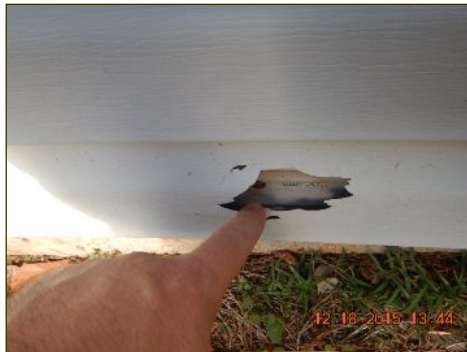
2.1. FYI: Minor damage was observed on the siding in various locations. This is typical of wear and tear on the cladding system. These should be sealed or repaired to prevent moisture intrusion.

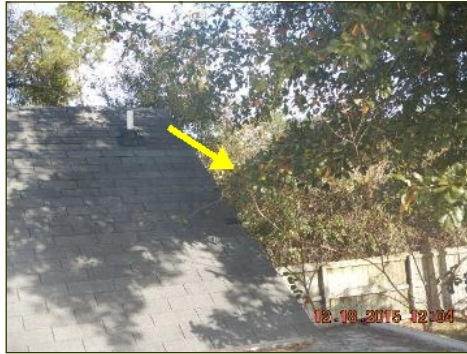
6.1. Tree branches were observed within close proximity of the roof. These should be trimmed to avoid potential damage to the roofing system.

Recommend trimming tree branches

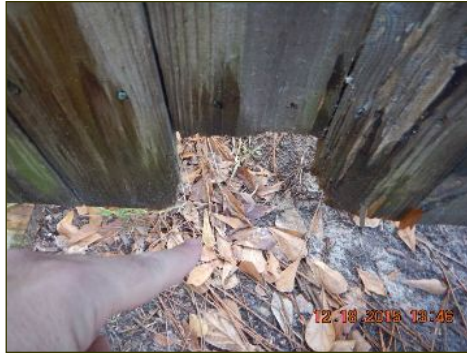
9.1. • Repair: Minor repairs are needed at the fence in various locations.

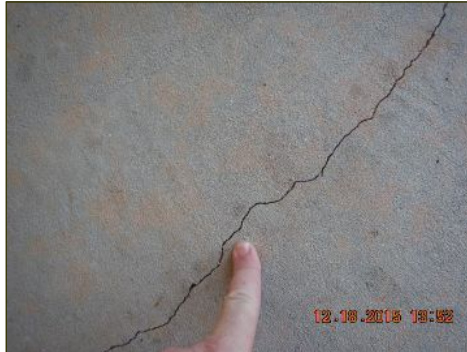
1.1. FYI: Typical cracking was observed at the garage

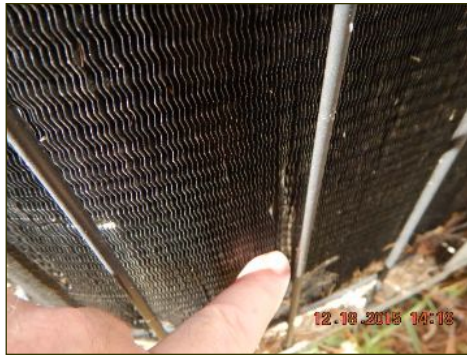
7.1. • FYI: Damage was visible on the coil fins servicing the heat pump. This may affect the systems efficiency.

Fin damage observed on heat pump

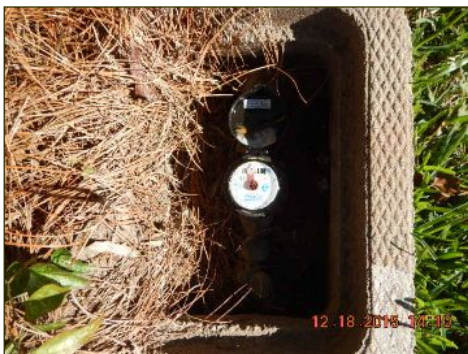
Recommend cleaning debris from meter

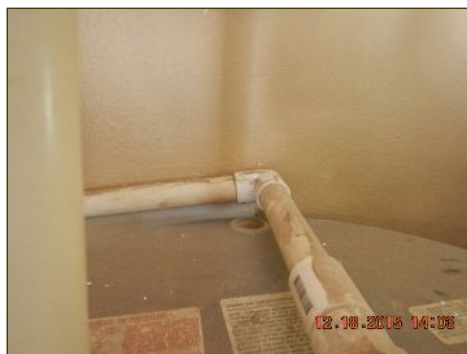
5.1. • Repair: The piping servicing the **IPR valve** was observed as PVC. PVC is not temperature or pressure rated for this application. Recommend installing piping compatible for this system.

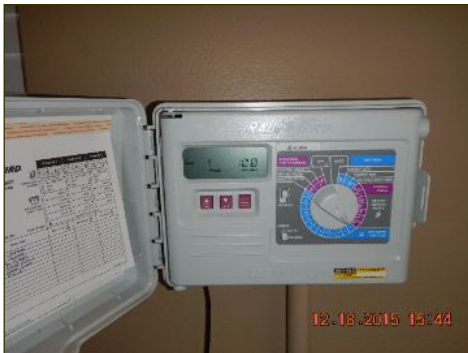
- 8.1. FYI: The sprinkler system was not tested due to the well being inoperative at the time of the inspection.

- 8.2. • **Repair:** Although energy was being delivered to the well, it was inoperative at the time of the inspection. Recommend consulting with a licensed plumber to recommend further evaluation and correction.

Sprinkler system not tested

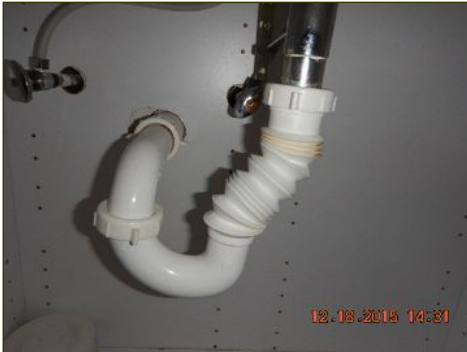
5.2. • Repair: Corrugated drain pipes were observed servicing the sinks in both bathrooms. Corrugated drain lines should be replaced with proper plumbing materials

Corrugated drain pipe

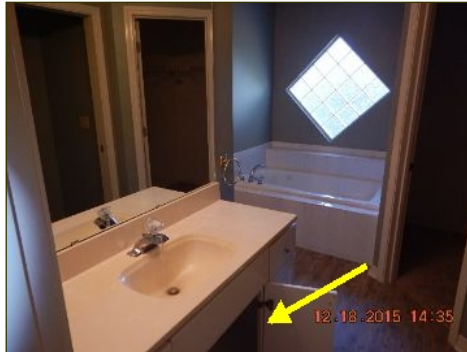
5.1. • Repair: The supply valve servicing the sink in the master bathroom on the south wall was observed leaking at the time of the inspection.

Location of leaking supply valve

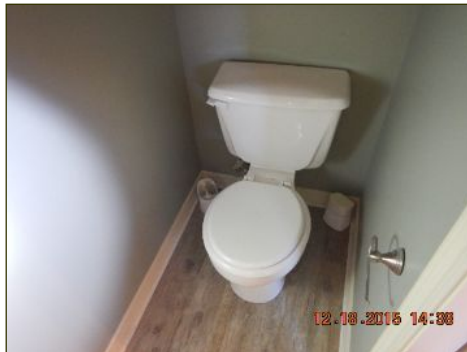
6.2. • Repair: The toilet in master bathroom is loose. Recommend securing to the floor as needed.

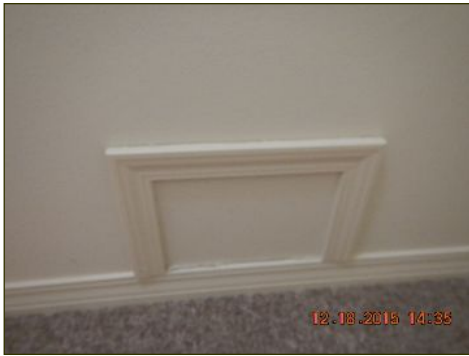
7.1. • Improve: Motor access should be provided to the whirlpool tub without damaging the structure or finish of the enclosure. While access was provided, it was sealed at the time of the inspection.

Motor access sealed

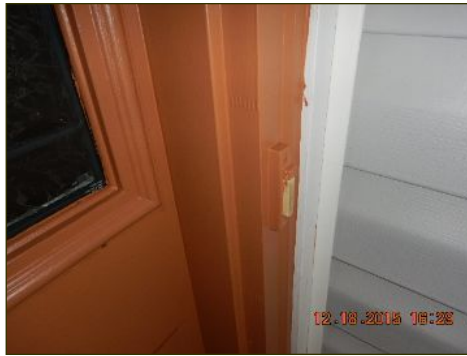
2.1. • FYI: The doorbell did not operate when tested. Recommend checking the door bell button, chime & transformer & replace or repair as needed.

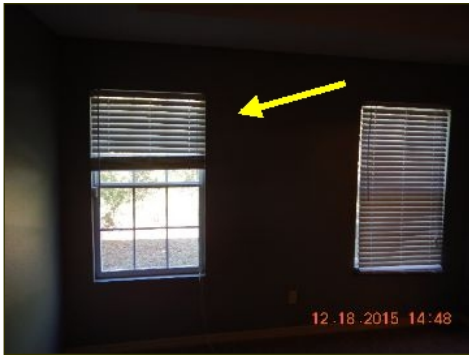
5.1. • Repair: A window in the master bedroom was inoperative at the time of the inspection. This should be repaired

Window in master bedroom inoperable

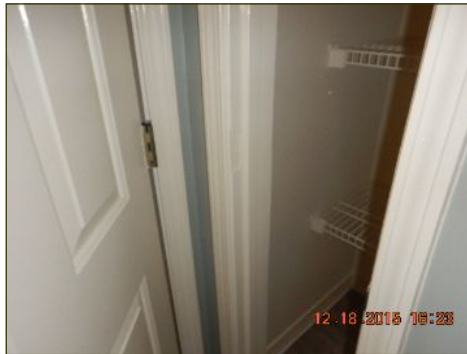
6.1. • FYI: A closet in the master bathroom was missing a door at the time of the inspection.

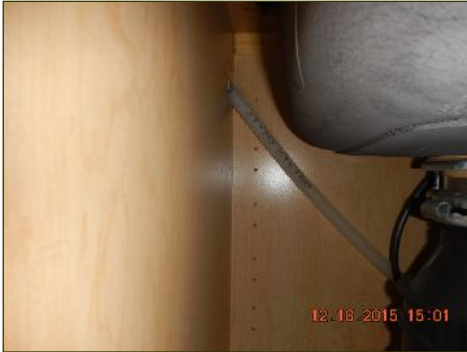
5.2. • **Repair:** Dishwasher drain hoses should be equipped with a high loop system. This is designed to prevent potential backflow contamination of the dishwasher.

No high loop to dishwasher drain hose
