ISLAND
INSPECTIONS

1600 Anywhere Street, Orange Beach, AL 36561
Inspection prepared for: Mr. Home Buyer
Date of Inspection: 12/17/2015

Report Summary

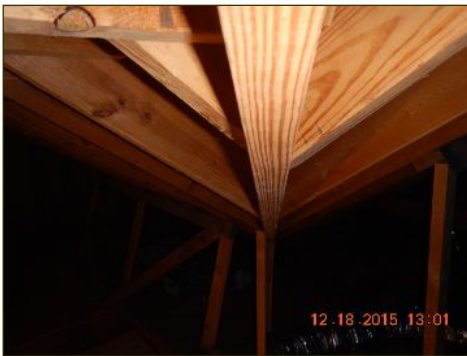
7.1. • Repair: Moisture intrusion was apparent where the the flat roof/chimney servicing the porch meets the home. Rot/deterioration was apparent on the roof sheathing. The chimney is within close proximity of the damaged sheathing. While it is suspected the chimney is the source of the leak, it could not be confirmed at the time of the inspection. Moisture intrusion was also observed on the North side of the home at the bottom of the roof decking within close proximity to the eave. This is believed to be from unsealed shingles. These areas should be further evaluated and repaired by a qualified roofing contractor.

No staining observed at roof valley

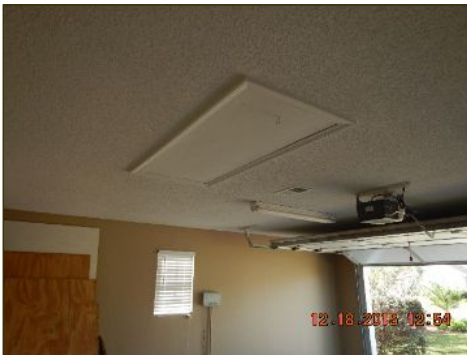
Access located in garage

9.2. • Safety Issue: The stairs servicing the attic entrance were operating in a manner inconsistent with its intended purpose. This represents a trip hazard, and should be repaired for improved safety.

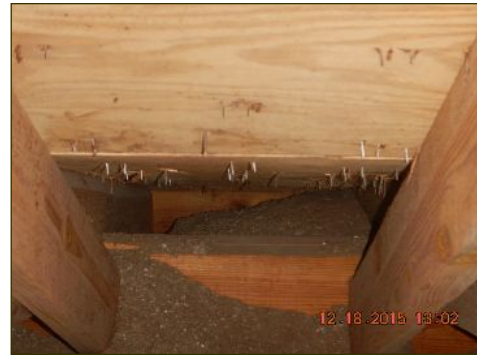
Soffit vents congested in various locations

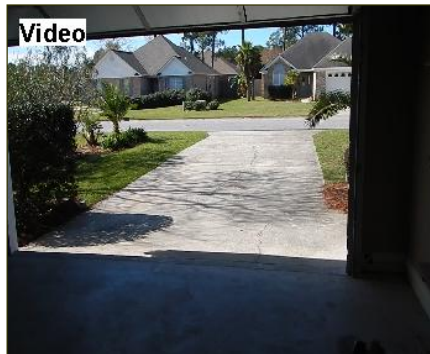
3.1. • **Safety Issue:** The garage door would not reverse when meet with resistance.

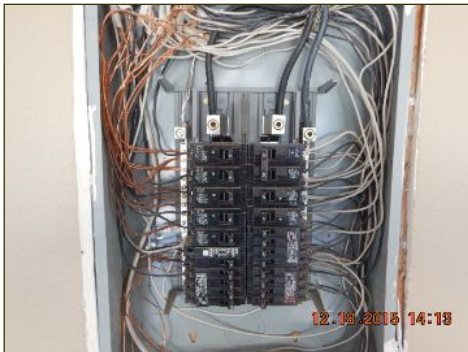
Sub Panel in good condition

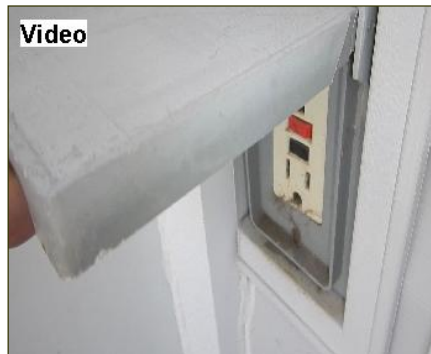
11.2. • Repair: A GFCI outlet located on the porch was inoperative at the time of the inspection.

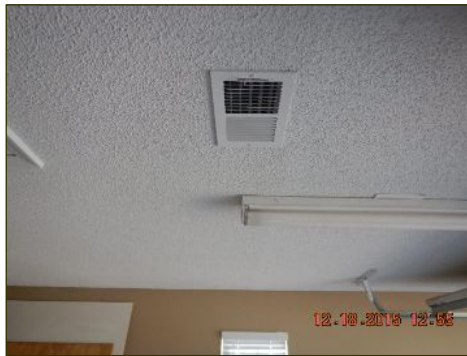
8.1. • FYI: An air register was observed on the ceiling in the garage. This was connected to the air supply at the time of the inspection

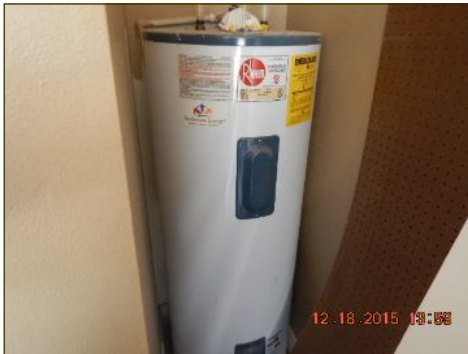
View of water heater

5.1. • Repair: The piping servicing the **IPR valve** was observed as PVC. PVC is not temperature or pressure rated for this application. Recommend installing piping compatible for this system.

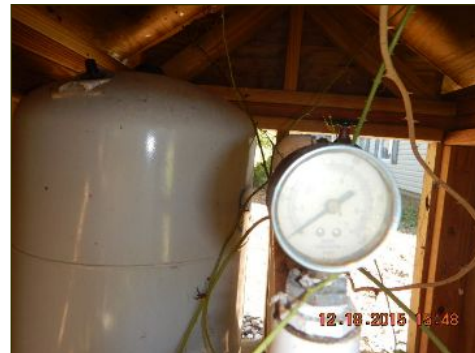
- 8.2. • **Repair:** Although energy was being delivered to the well, it was inoperative at the time of the inspection. Recommend consulting with a licensed plumber to recommend further evaluation and correction.

Well inoperative

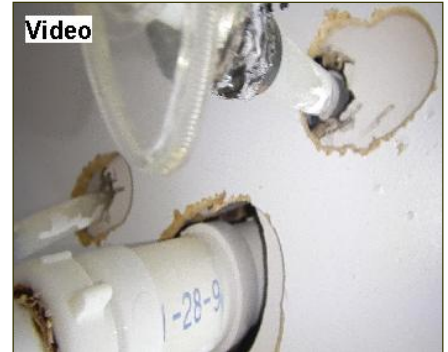
5.1. • Repair: The supply valve servicing the sink in the master bathroom on the south wall was observed leaking at the time of the inspection.

Click to watch video of leaking supply valve

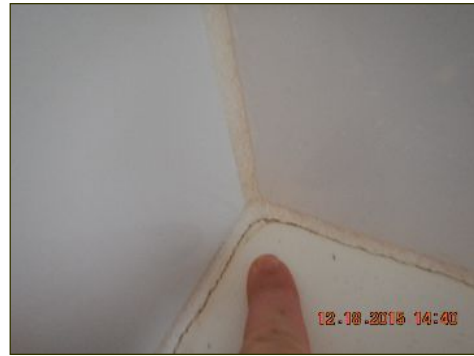
Caulking maintenance needed at whirlpool tub

7.2. • Improve: Bathtub enclosures should be caulked to minimize the potential for moisture intrusion.

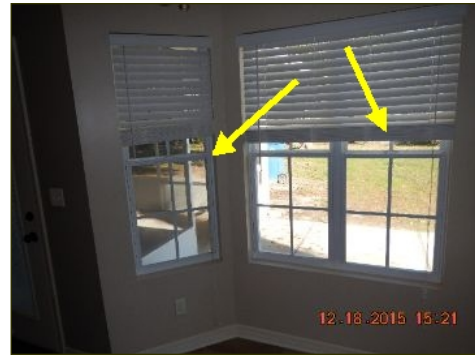
Windows should be adjusted so they remain upright

5.2. • Repair: The windows in the kitchen should be adjusted so they remain in the upright position when left unattended.

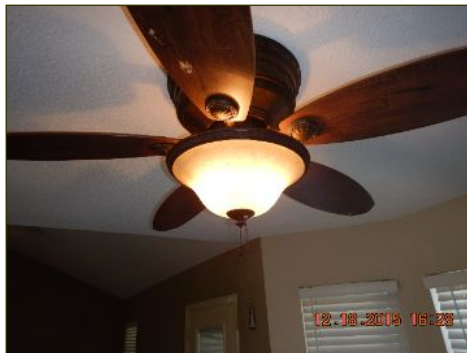
7.1. • FYI: The fan in the dining room was inoperative at the time of the inspection.

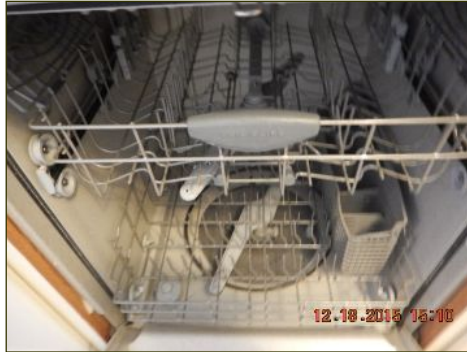
Dishwasher drained appropriately

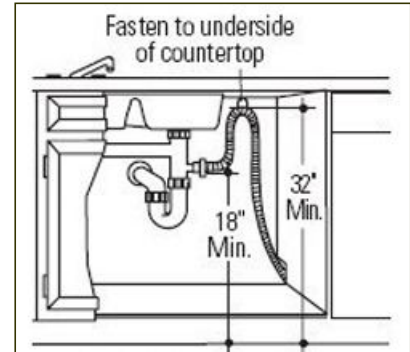
Example of high loop system

5.2. • **Repair:** Dishwasher drain hoses should be equipped with a high loop system. This is designed to prevent potential backflow contamination of the dishwasher.

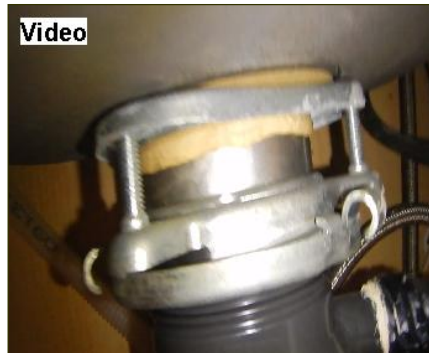
6.1. • **Repair:** The disposal was leaking at the time of the inspection. This should be replaced.

Click to watch video

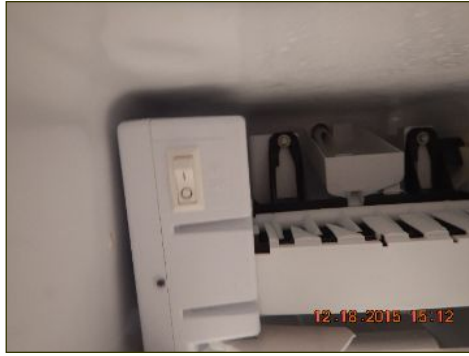
Ice maker not energized at time of the inspection
